Imaging Sciences Interesting Cases

CASE 189

DIAGNOSIS: Gallstones

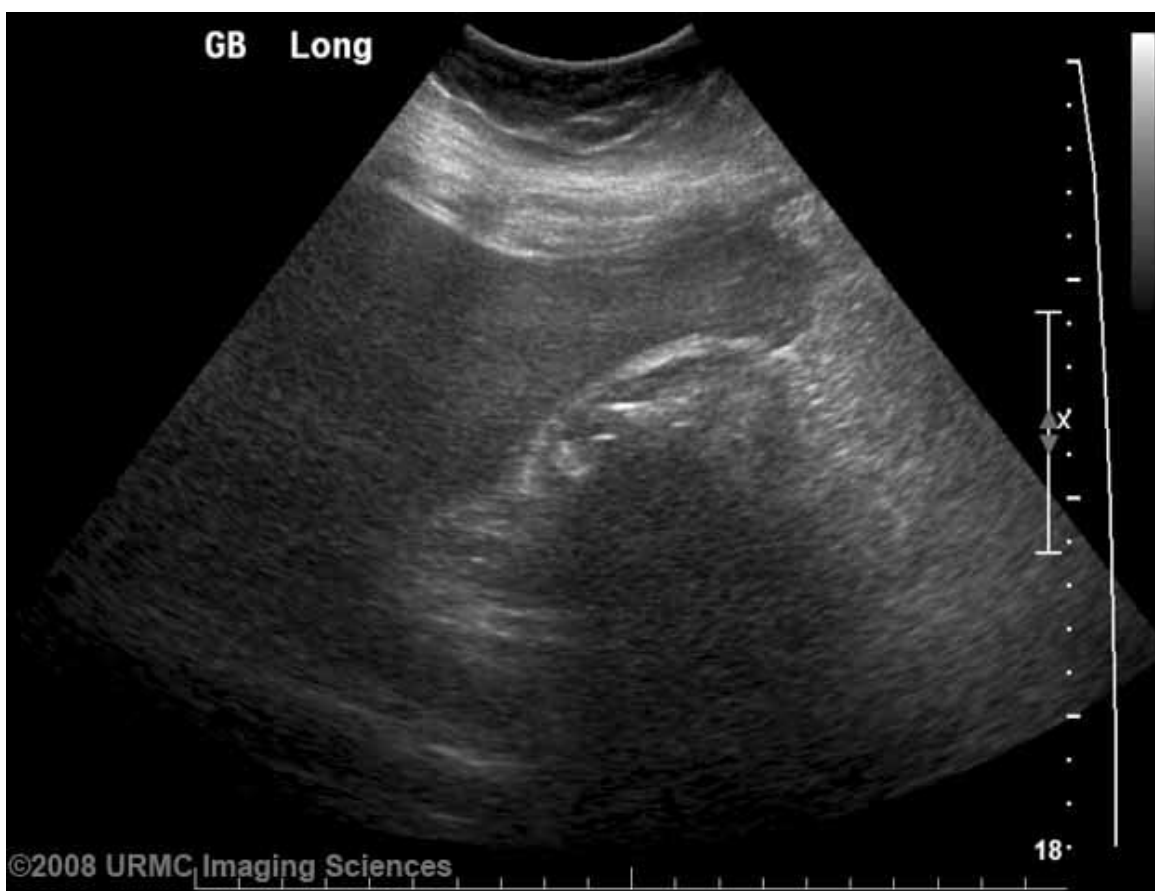
Figure 1: Right upper quadrant ultrasound image demonstrates an irregular echogenic line just deep to an echogenic, curvilinear gallbladder wall. Posterior acoustic shadowing is present.

Specifically, the WES sign is composed of two parallel, curvilinear, echogenic lines defined by an intervening hypoechoic space. The near field echogenic line represents the gallbladder wall, while the deeper line is the surface of the gallstone(s). The hypoechoic layer sandwiched between the wall and the gallstones is

attributed to bile. Acoustic shadowing deep to the far field echogenic line results from heterogeneous attenuation of the ultrasound beam by the gallstones.
