## Imaging Sciences Interesting Cases

### CASE 37

### **DIAGNOSIS: ACL INJURY**

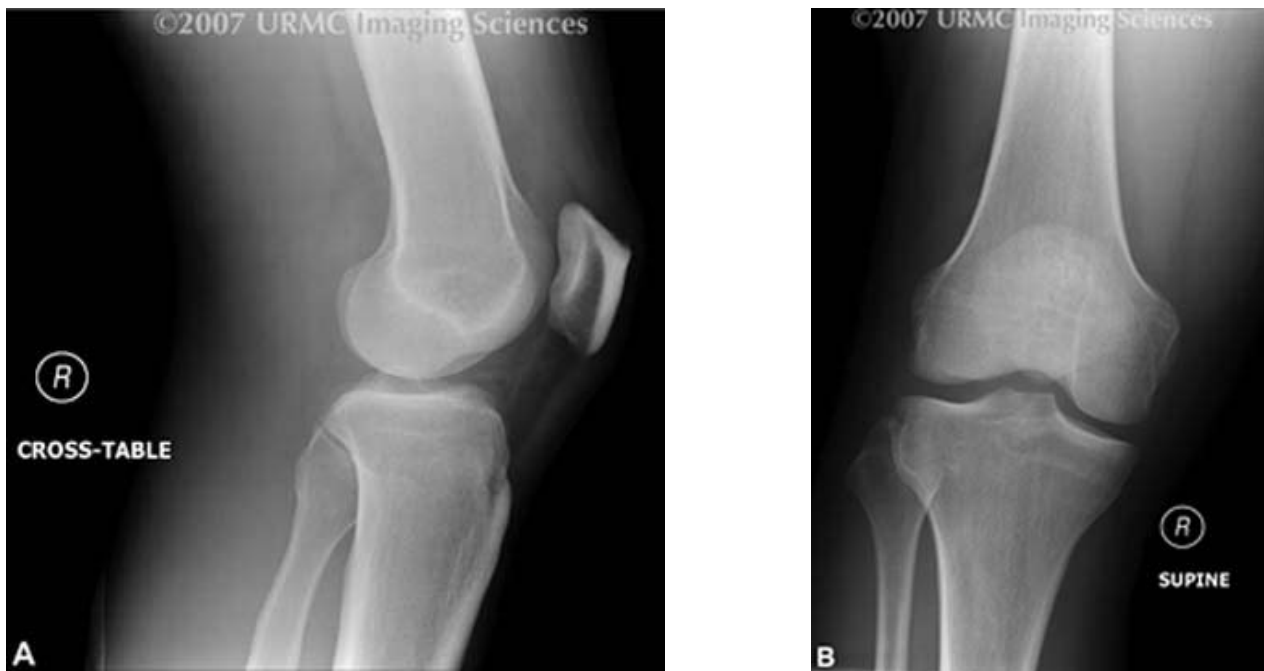
**Figure 1 A&B**

**IMAGING FINDINGS:** Moderate sized joint effusion is seen. No fracture, dislocation, or significant arthritic changes are present. Enlarged lateral femoral condyle sulcus is evident well consistent with the clinical diagnosis of ACL injury.

**DISCUSSION:** This study demonstrates the lateral femoral notch sign. This has been described as an indirect sign of torn ACL. It is best seen on the lateral radiograph and is characterized by an abnormally deep depression of the lateral condylopatellar sulcus. Normally this is a shallow groove notch that indicates an impacted osteochondral fracture or a localized chondral or transchondral abnormality overlying the lateral femoral notch. This has been observed with torn ACL.

Depth of lateral femoral notch can be measured on lateral radiograph by drawing a tangent line across the sulcus on its articular surface of the lateral femoral condyle. Measure depth perpendicular to line at deepest point. Depending on the study it has been suggested that a notch greater than 1.5-2.0 mm is highly suggestive of ACL injury. Limitation of the sign remains distinguishing a prominent but normal lateral femoral notch from a shallow impacted fracture of the sulcus. This sign is important to recognize so that
