**Imaging Sciences Interesting Cases**

**CASE 40**

## **DIAGNOSIS: Calcified Breast Implants**

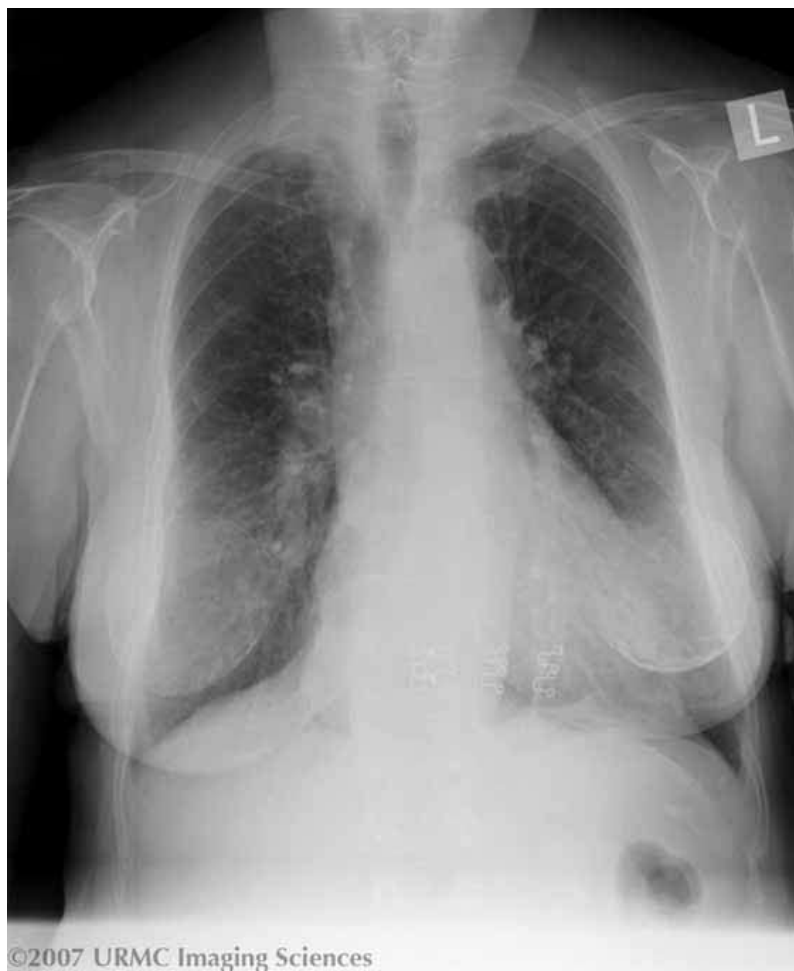
**Figure 1.** PA chest radiograph demonstrates lungs clear of acute disease, however there are two rounded densities which project over the breasts. A double right cardiac density is also seen, compatible with a hiatal hernia.

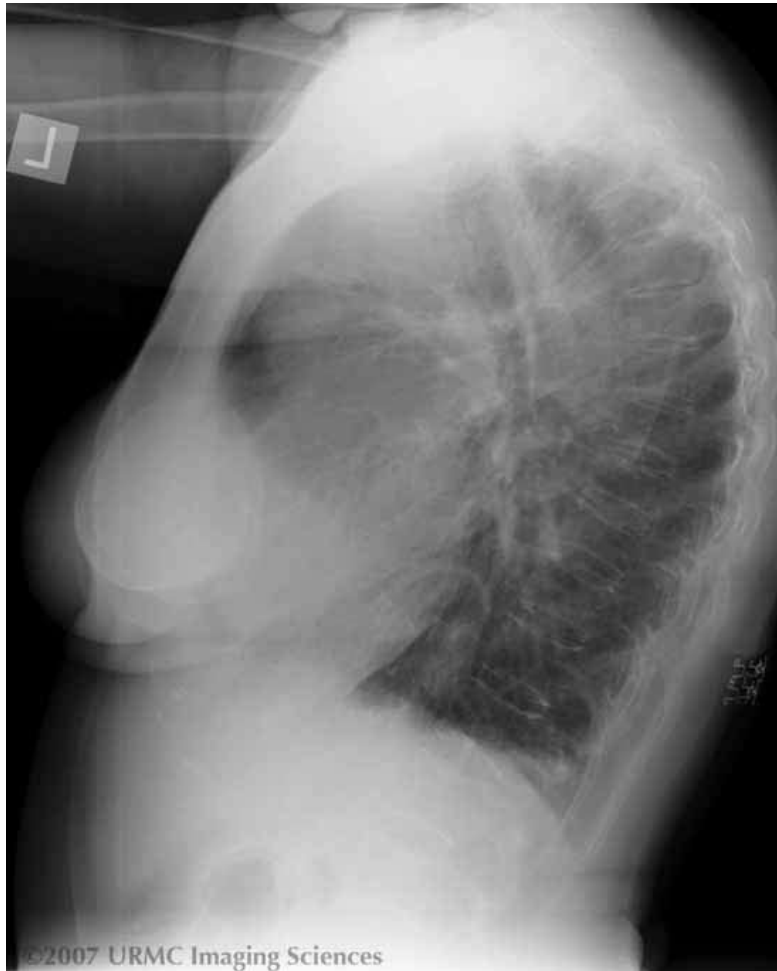
**Figure 2.** Lateral chest radiograph demonstrates the rounded masses to project over the anterior chest wall.

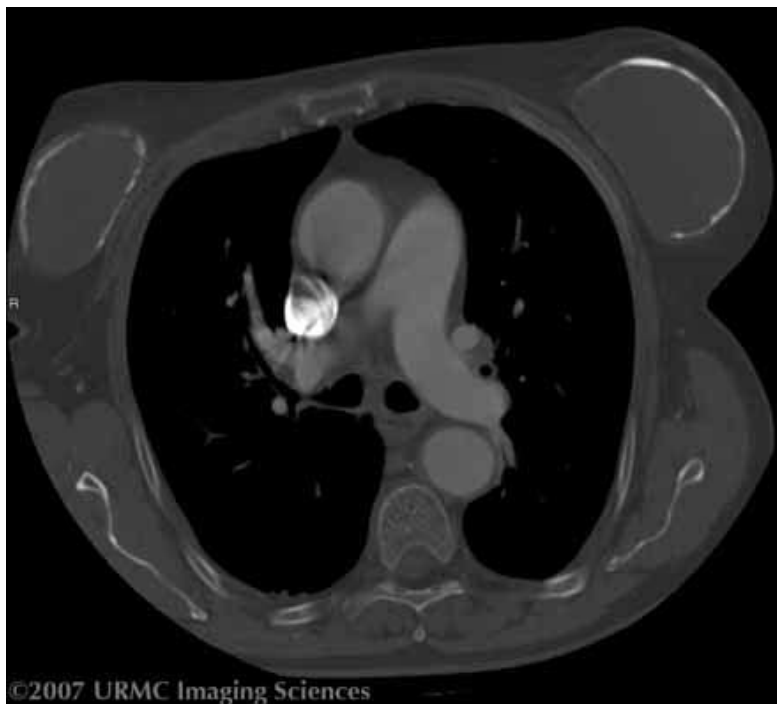
**Figure 3.** Axial CT image, bone windowing, shows calcifications surrounding breast implants. (Compare the density to bone.) There is also an increased AP diameter of the thorax, compatible with emphysema.

**DISCUSSION:** The body naturally forms a reactive fibrous capsule around a breast implant. Calcifications can form in this fibrous capsule. The calcifications are in the form of hydroxyapatite crystals within the fibrous capsule or on the surface of the capsule. They appear as plaque-like deposits near the surface of the implant. Normal implants appear semi-ovoid on lateral views. They become rounder and harder with capsule formation.
