Imaging Sciences Interesting Cases

CASE 46

IMAGING FINDINGS: Gallstones with gallbladder wall thickening and a common bile duct stone.

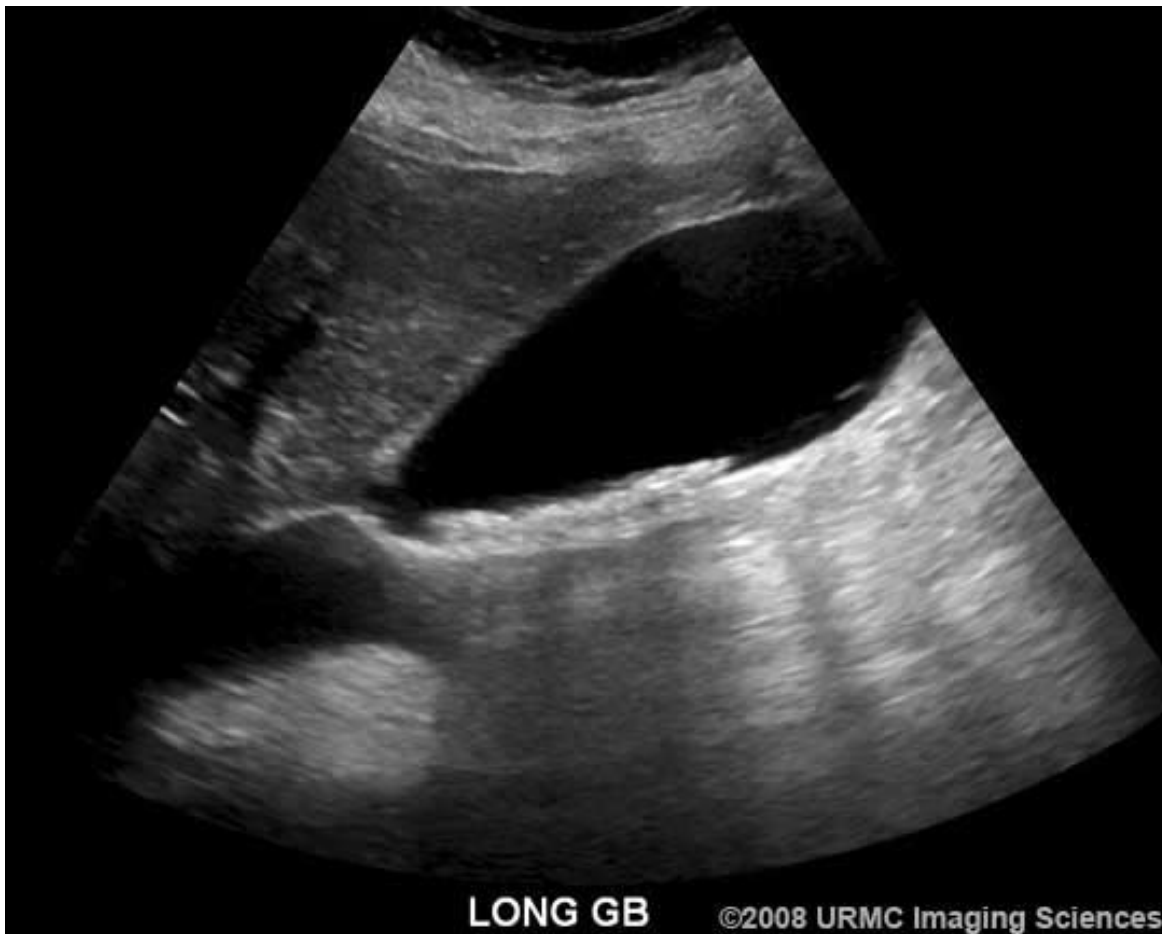
Figure 1: Multiple gallstones with shadowing.

The ultrasound features of chronic cholecystitis are a thick-walled gallbladder, sometimes distended, sometimes scarred down because of continued fibrosis. Gallstones and sludge can be seen as echogenic foci that may shadow if sufficiently large. Features supporting acute cholecystitis include peri-cholecystic fluid, gallbladder wall thickening due to edema, a non-mobile stone seen at the cystic duct, and a positive sonographic Murphy's sign. A positive Murphy's sign is elicited by the sonographer as the probe is placed directly over the gallbladder such that the parietal peritoneal surface can contact the gallbladder serosa when the patient takes a deep breath.

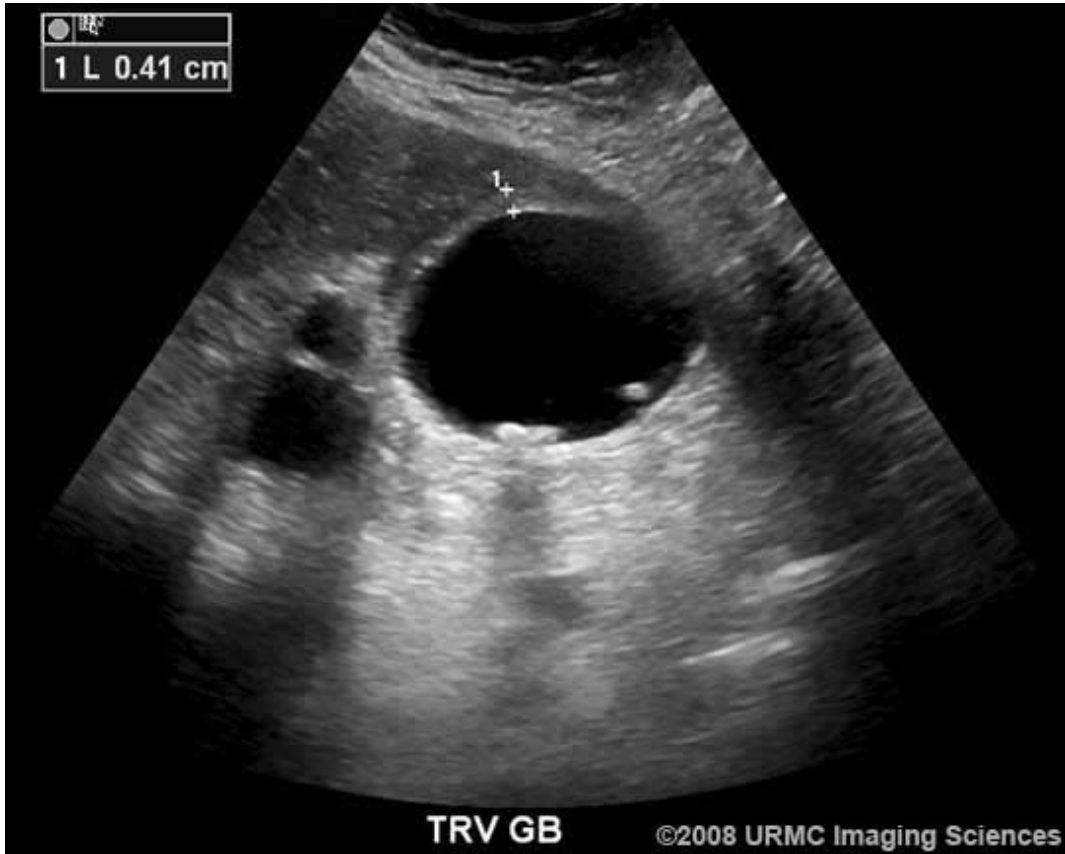
Figure 2: Gallbladder wall thickening, measuring 4.1 mm.

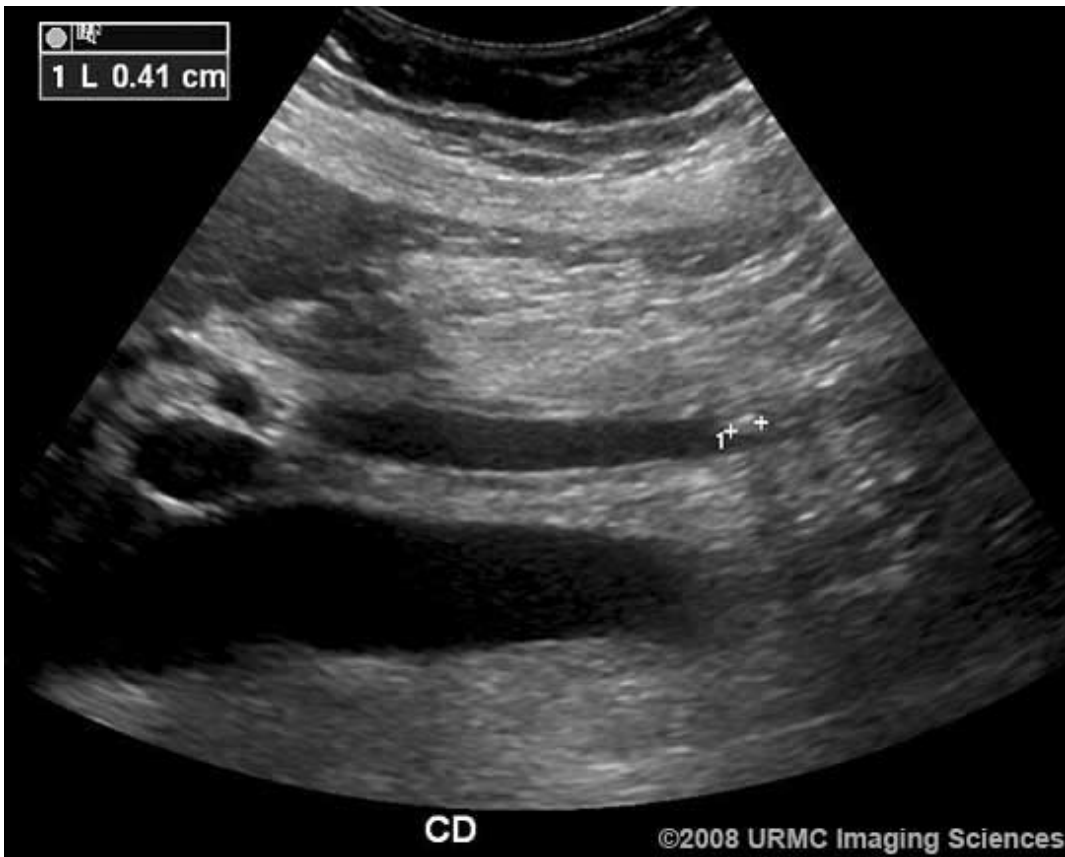
Figure 3: Stone visualized in the common bile duct

Choledocholithiasis is a stone within the common bile duct. Although very difficult to diagnosis by ultrasound, the third image clearly demonstrates an echogenic focus with shadowing consistent with a gallstone. The distal duct as it enters the pancreas is difficult to visualize by ultrasound. Secondary signs of choledocholithiasis include common bile duct thickening.
